The Torresdale Conduit.*

BY JOHN W. HILL,

Chief Engineer, Bureau of Filtration, Philadelphia.

The Torresdale Conduit, Contract No. 14, Improvement, Extension and Filtration of the Water Supply of Philadelphia, is a large inverted syphon intended to conduct the filtered water from the clear water basin at Torresdale to the pumping station at Lardner's Point. Its nominal capacity is 300,000,000 gallons per day of twenty-four hours, with a loss of head between

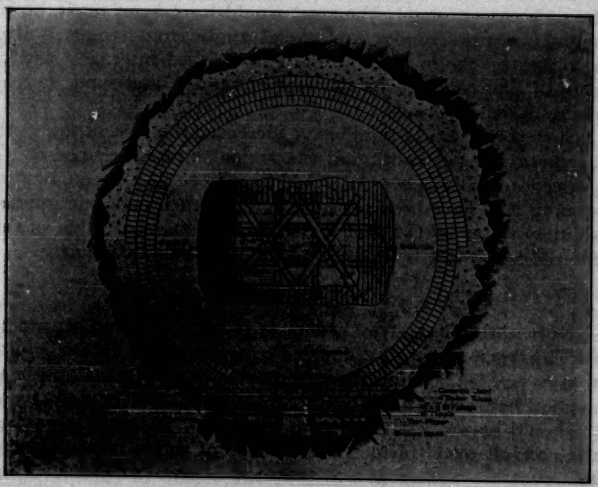
PLATE XXX.—Method of Closing Sump, Shaft No. 2.

At the open sump at Shaft No. 2 a different plan was adopted. Here the original plan was to square the opening carefully to the smallest possible dimensions; fill the hole with coarse gravel, set above it on the invert a stout wooden form braced down and made watertight by caulking around the edges, and pump grout into the opening under fifty or sixty pounds' pressure through a two-inch pipe set in the form. In cutting out the hole the workmen misunderstood orders and made the sump large enough to receive the form. This mistake or blunder caused at least two weeks additional work, and largely increased the cost and difficulty of closing the sump.

Several expedients were adopted and failed of the purpose, and finally a No. 4 centrifugal pump of 400 gallons capacity per minute was set up near the sump. An alternating current motor was procured and set up on a temporary timber platform, and belted to the pump, and the current to operate the motor carried in from Shaft No. 1, a distance of 1,400 feet. The suction of the pump was then set in the bottom of the sump, and the discharge set in a sluice box which delivered the water north of a temporary sand bag and clay dam placed north of the sump.

In the center of the sump, on a coarse gravel foundation as at Shaft No. 1, a short length of twelve-inch steam pipe with a flange top and bottom was set, with the upper flange about five inches below the line of tunnel invert. In this nipple was set the suction pipe of the centrifugal pump, which was operated constantly day and night to keep the opening dry.
